Design Build Broad River Fishing Pier
Rehabilitation

Beaufort, SC

October 2, 2015

RE: Broad River Fishing Pier Rehabilitation
Stage I Inspection, Testing, Engineering and Recommendations
RFP 092314

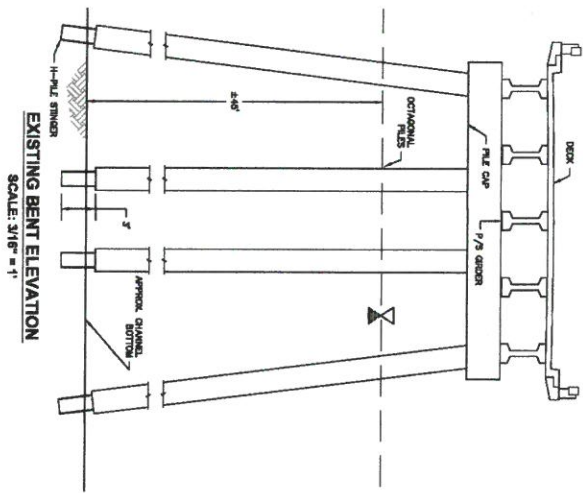
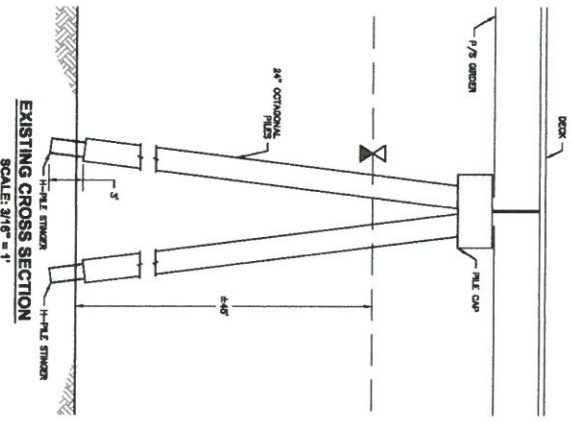
EXISTING

The most significant deficiency encountered was the undermining of foundation elements in two locations. Exposed H-Pile stingers at the bottom of concrete piles were discovered at Bents 8 and 9. At Bent 8, all of the pile stingers were exposed, with a maximum of 10 inches. At Bent 9, three piles exhibited exposed stingers with a maximum exposure of 4 inches. Furthermore, exposed stingers exhibited as much as 2 inches of heavy scale and rust nodules, 100 percent loss of protective coating, and 100 percent loss of section on the H-Pile flanges. A review of the design plans indicated that these stingers are approximately 3 feet long. This represents a significant deficiency in that these bents are being supported by substantially less bearing area and friction forces than specified in the original design.

In addition I have included in the more detailed report information from the Engineers addressing Bents 8 and 9. At Bent 8 all 8 piles supporting the bents had exposed steel stringers with a maximum exposure of 10-in. at Pile D-East. Steel stringers were exposed a maximum of 4-in at piles A,B and C west on Bent 9. It should be noted that the full load of each octagonal pile is being carried by their respective stringers. Each stinger exhibited a heavy 1 to 2-in thick layer of heavy scale and nodules, 100 percent loss of protective coating and up to 100 percent loss of section on the H-Pile flanges. The design plans indicate a stinger length of 3 feet. This is an indication there is approximately 26 to 32 in of pile stinger embedment at these locations

This includes a type of post-tensioned retrofit to Bents 8 and 9. This method is similar to the technique employed on the southbound lanes of US 17 over the Ashley River in Charleston and consists of installing a new pile cap/footing on each side of the existing bent and designing some form of post tension system to connect these pile cap footings to the existing bent.

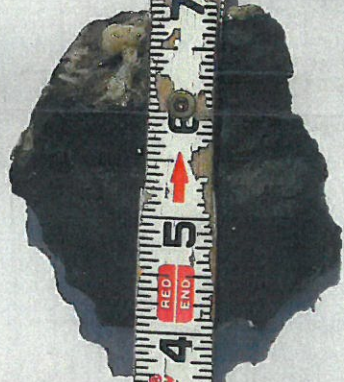
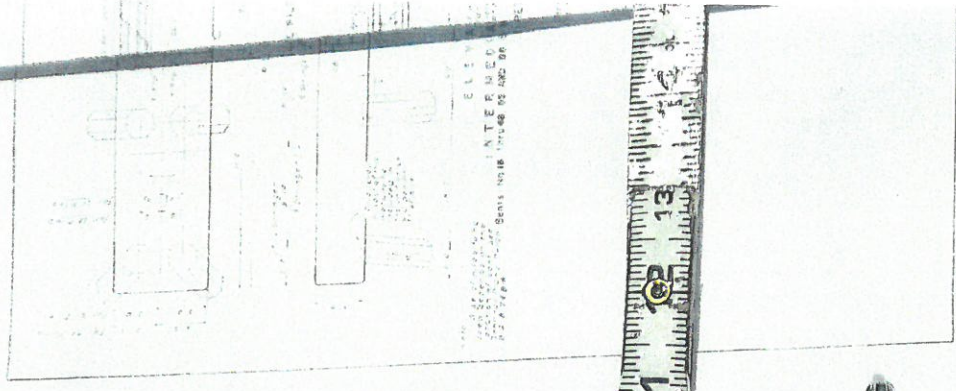
RUST
NODULE
Pile D-EAST
BENT 8

H-PILE
