**Fiscal Year 2009**

## Stormwater Utility

### Project Report

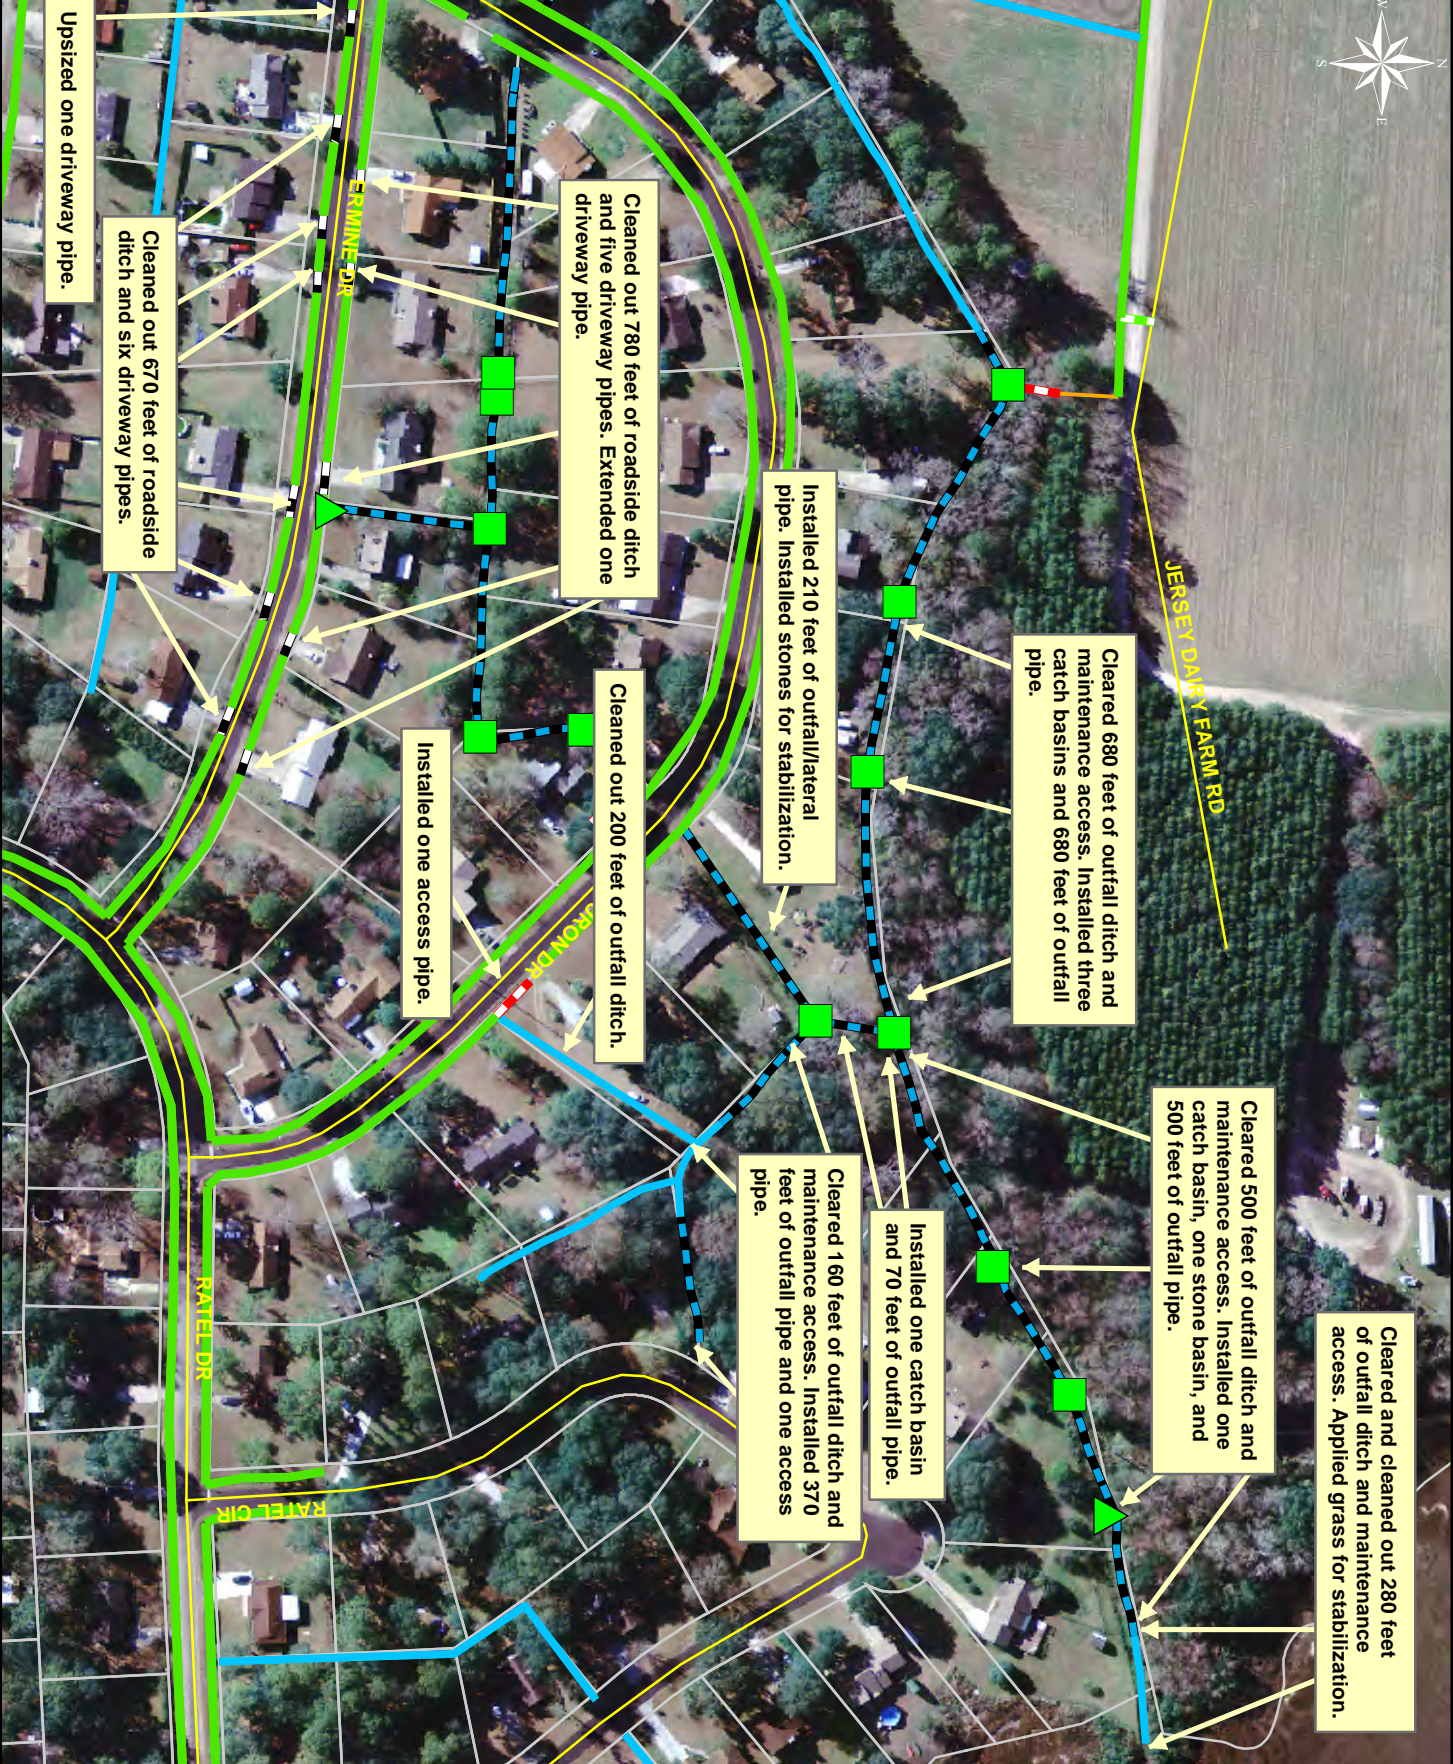
**Project:**  
Mink Point  
Map 1

**Drainage/Water Quality Issue:** The primary outfall ditch for this subdivision was wide, deep, and a safety hazard. Also, the access and easements for the drainage system within the subdivision were narrow and preventing the ditches from being routinely cleaned out.

**Resolution:** This project mowed 600 feet of outfall ditch, cleared 2,460 feet of outfall ditch and maintenance access, cleaned out 1,530 feet of roadside ditch, 1,080 feet of outfall ditch, and 90 feet of lateral ditches. The Utility also installed eleven catch basins, one crossline pipe, five access pipes, 2,610 feet of outfall pipe, 370 feet of lateral/outfall pipe, nine stone basins, upsized one driveway pipe, extended one driveway pipe, and cleaned out eleven driveway pipes. In addition, the Utility installed stones and applied grass for stabilization.

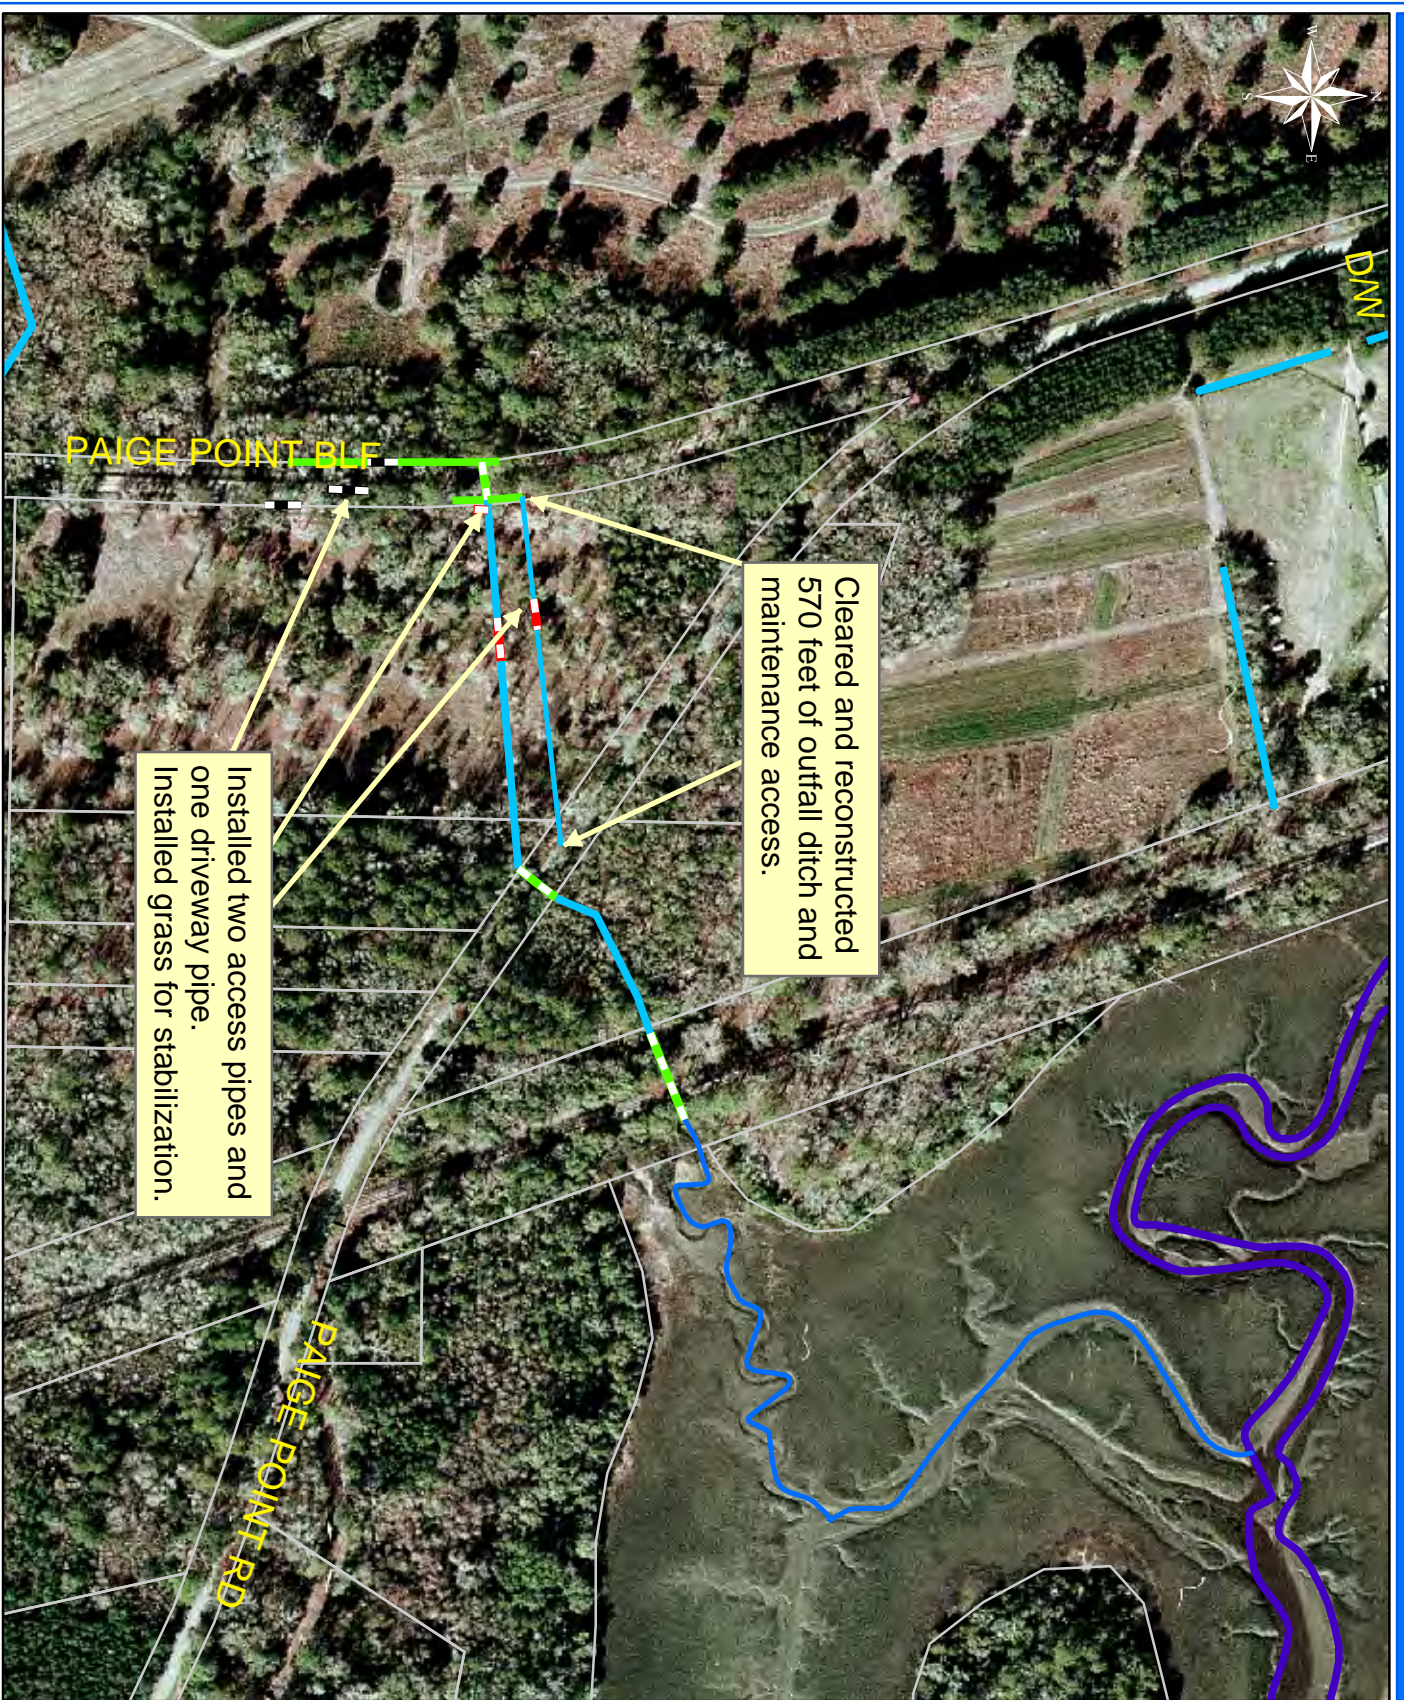
**Project:**  
Paige Point Bluff

**Drainage/Water Quality Issue:** Water was overtopping the roadside ditch.

**Resolution:** This project cleared and reconstructed 570 feet of outfall ditch and maintenance access. The Utility also installed one driveway pipe and two access pipes. Additionally, the Utility installed stones and applied grass for stabilization.

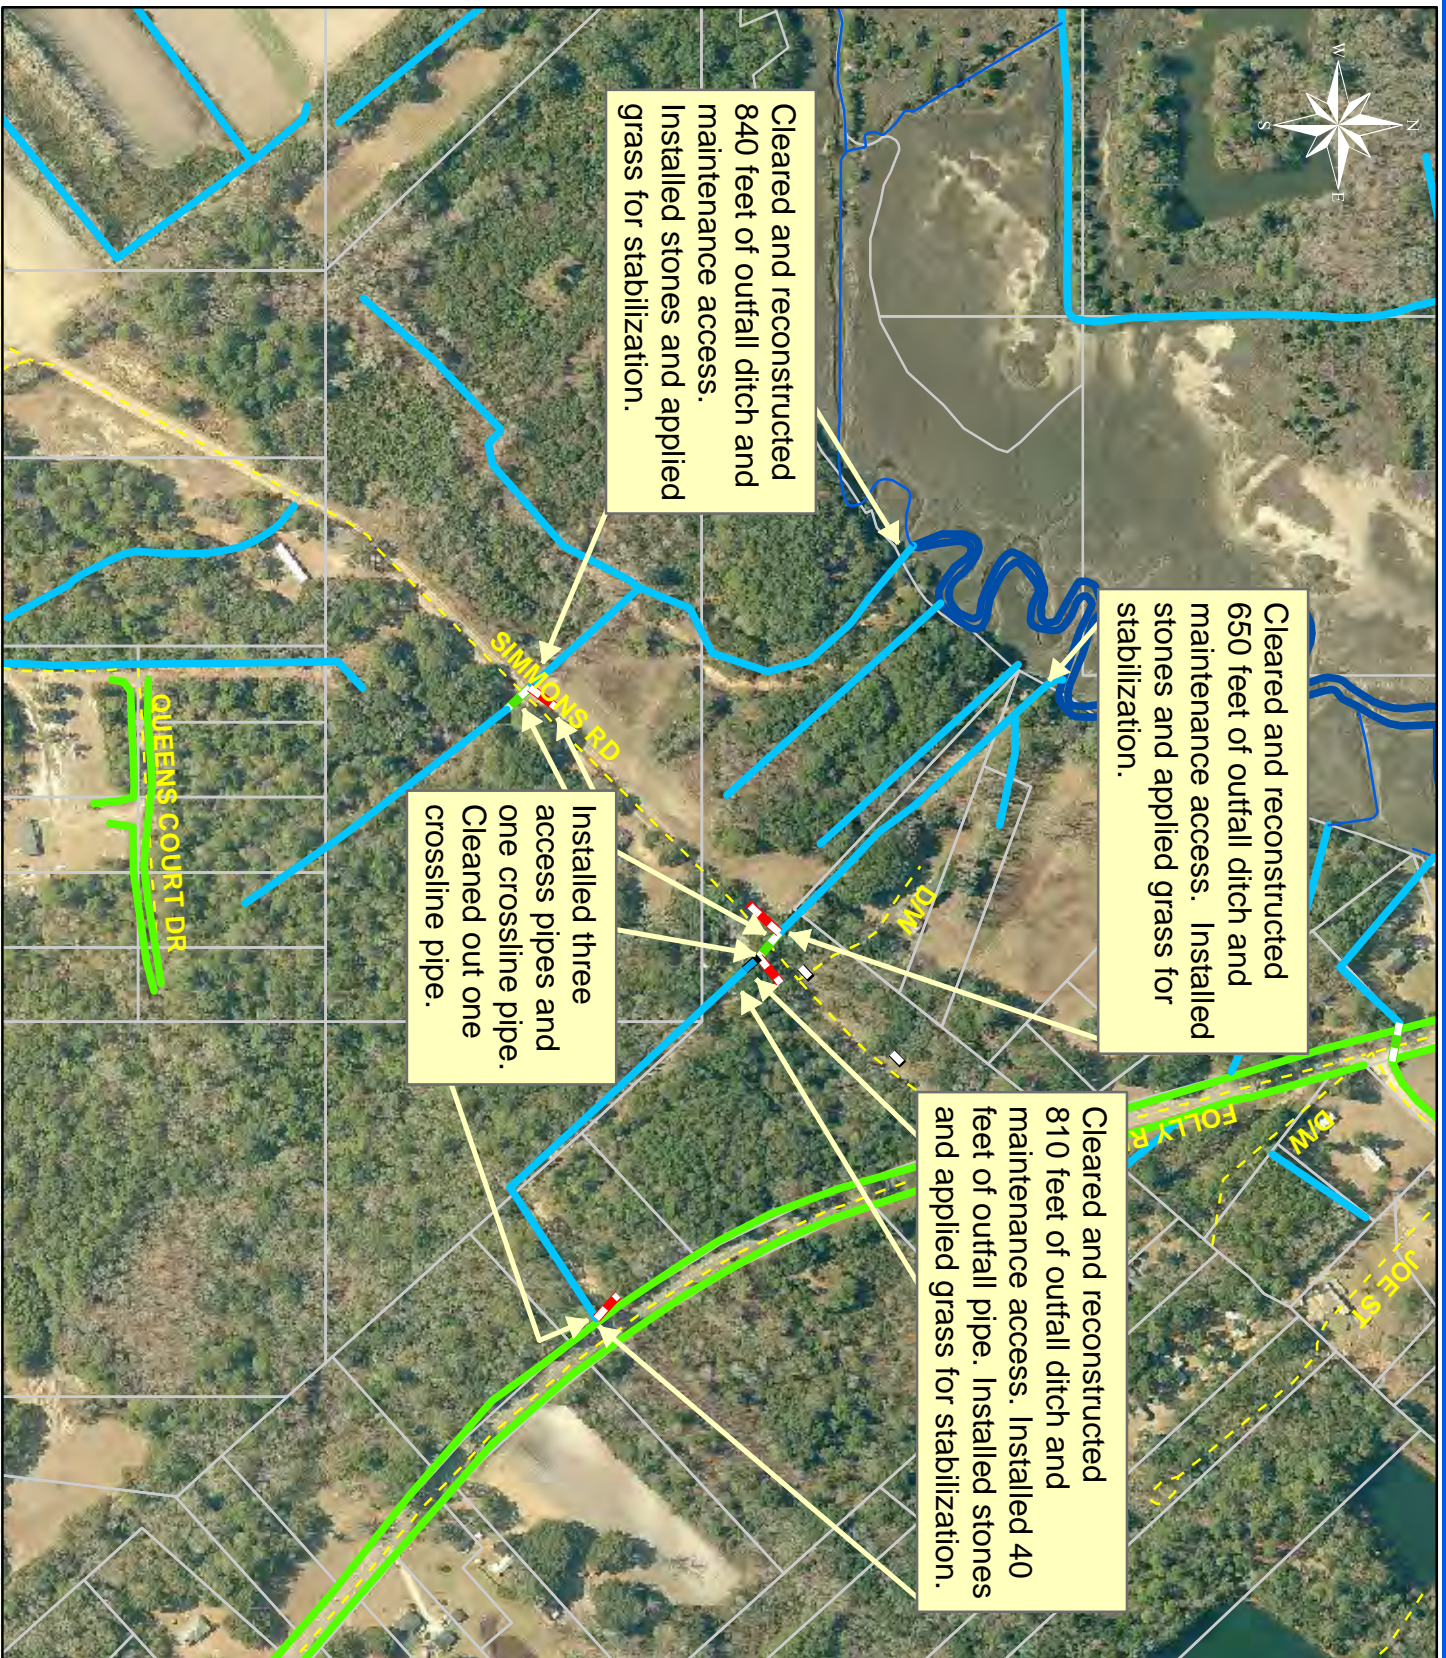
**Project:**  
Simmons Road

**Drainage/Water Quality Issue:** There was flooding and standing water on Simmons Road and standing water in the outfall ditches.

Cleared and reconstructed 650 feet of outfall ditch and maintenance access. Installed stones and applied grass for stabilization.

Cleared and reconstructed 840 feet of outfall ditch and maintenance access. Installed stones and applied grass for stabilization.

Cleared and reconstructed 810 feet of outfall ditch and maintenance access. Installed 40 feet of outfall pipe. Installed stones and applied grass for stabilization.

Installed three access pipes and one crossline pipe. Cleaned out one crossline pipe.

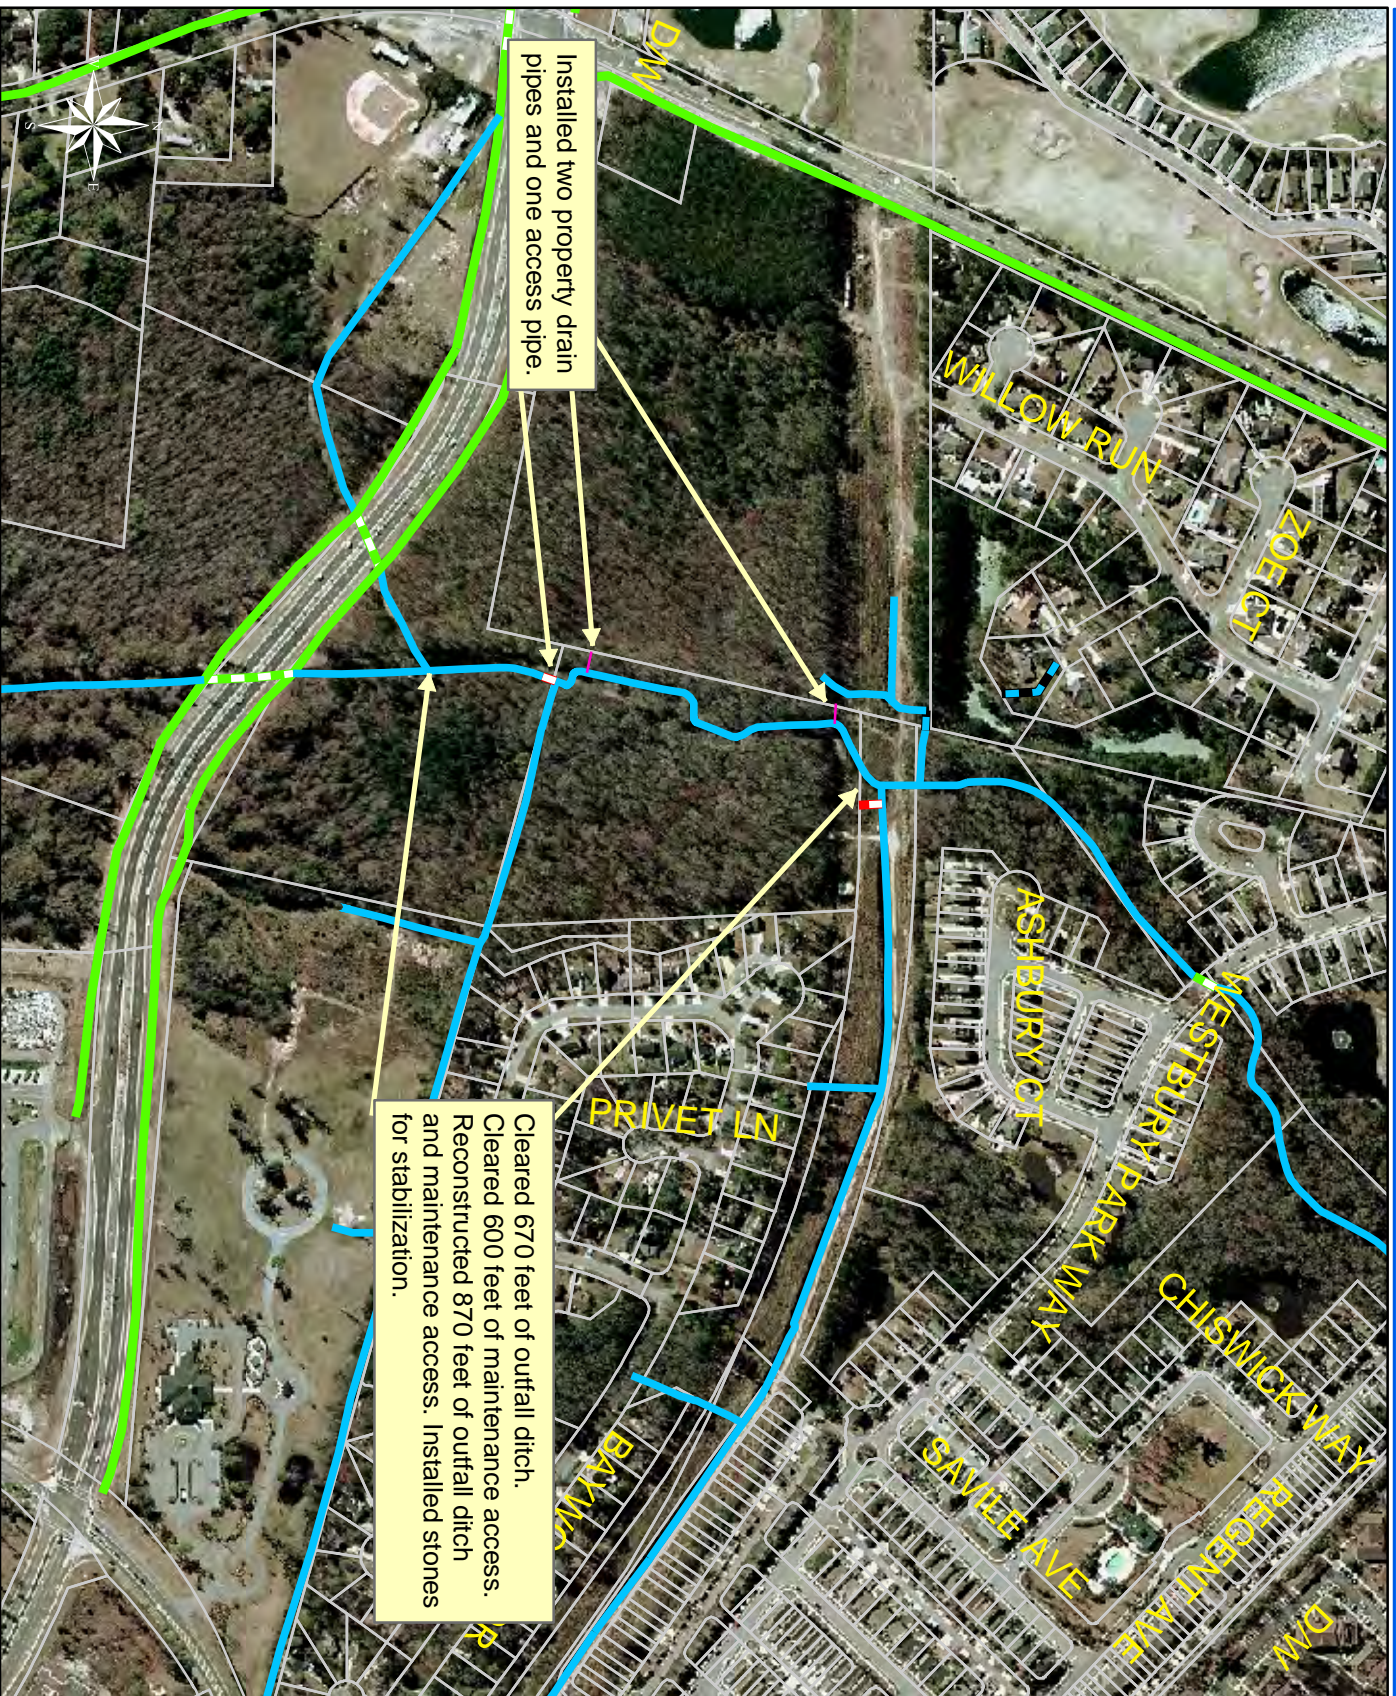
**Project:**  
Town of Bluffton - Bluffton Parkway

**Drainage/Water Quality Issue:** There was standing and stagnant water in the outfall ditch.

Installed two property drain pipes and one access pipe.

Cleared 670 feet of outfall ditch. Reconstructed 600 feet of maintenance access. Reconstructed 870 feet of outfall ditch and maintenance access. Installed stones for stabilization.

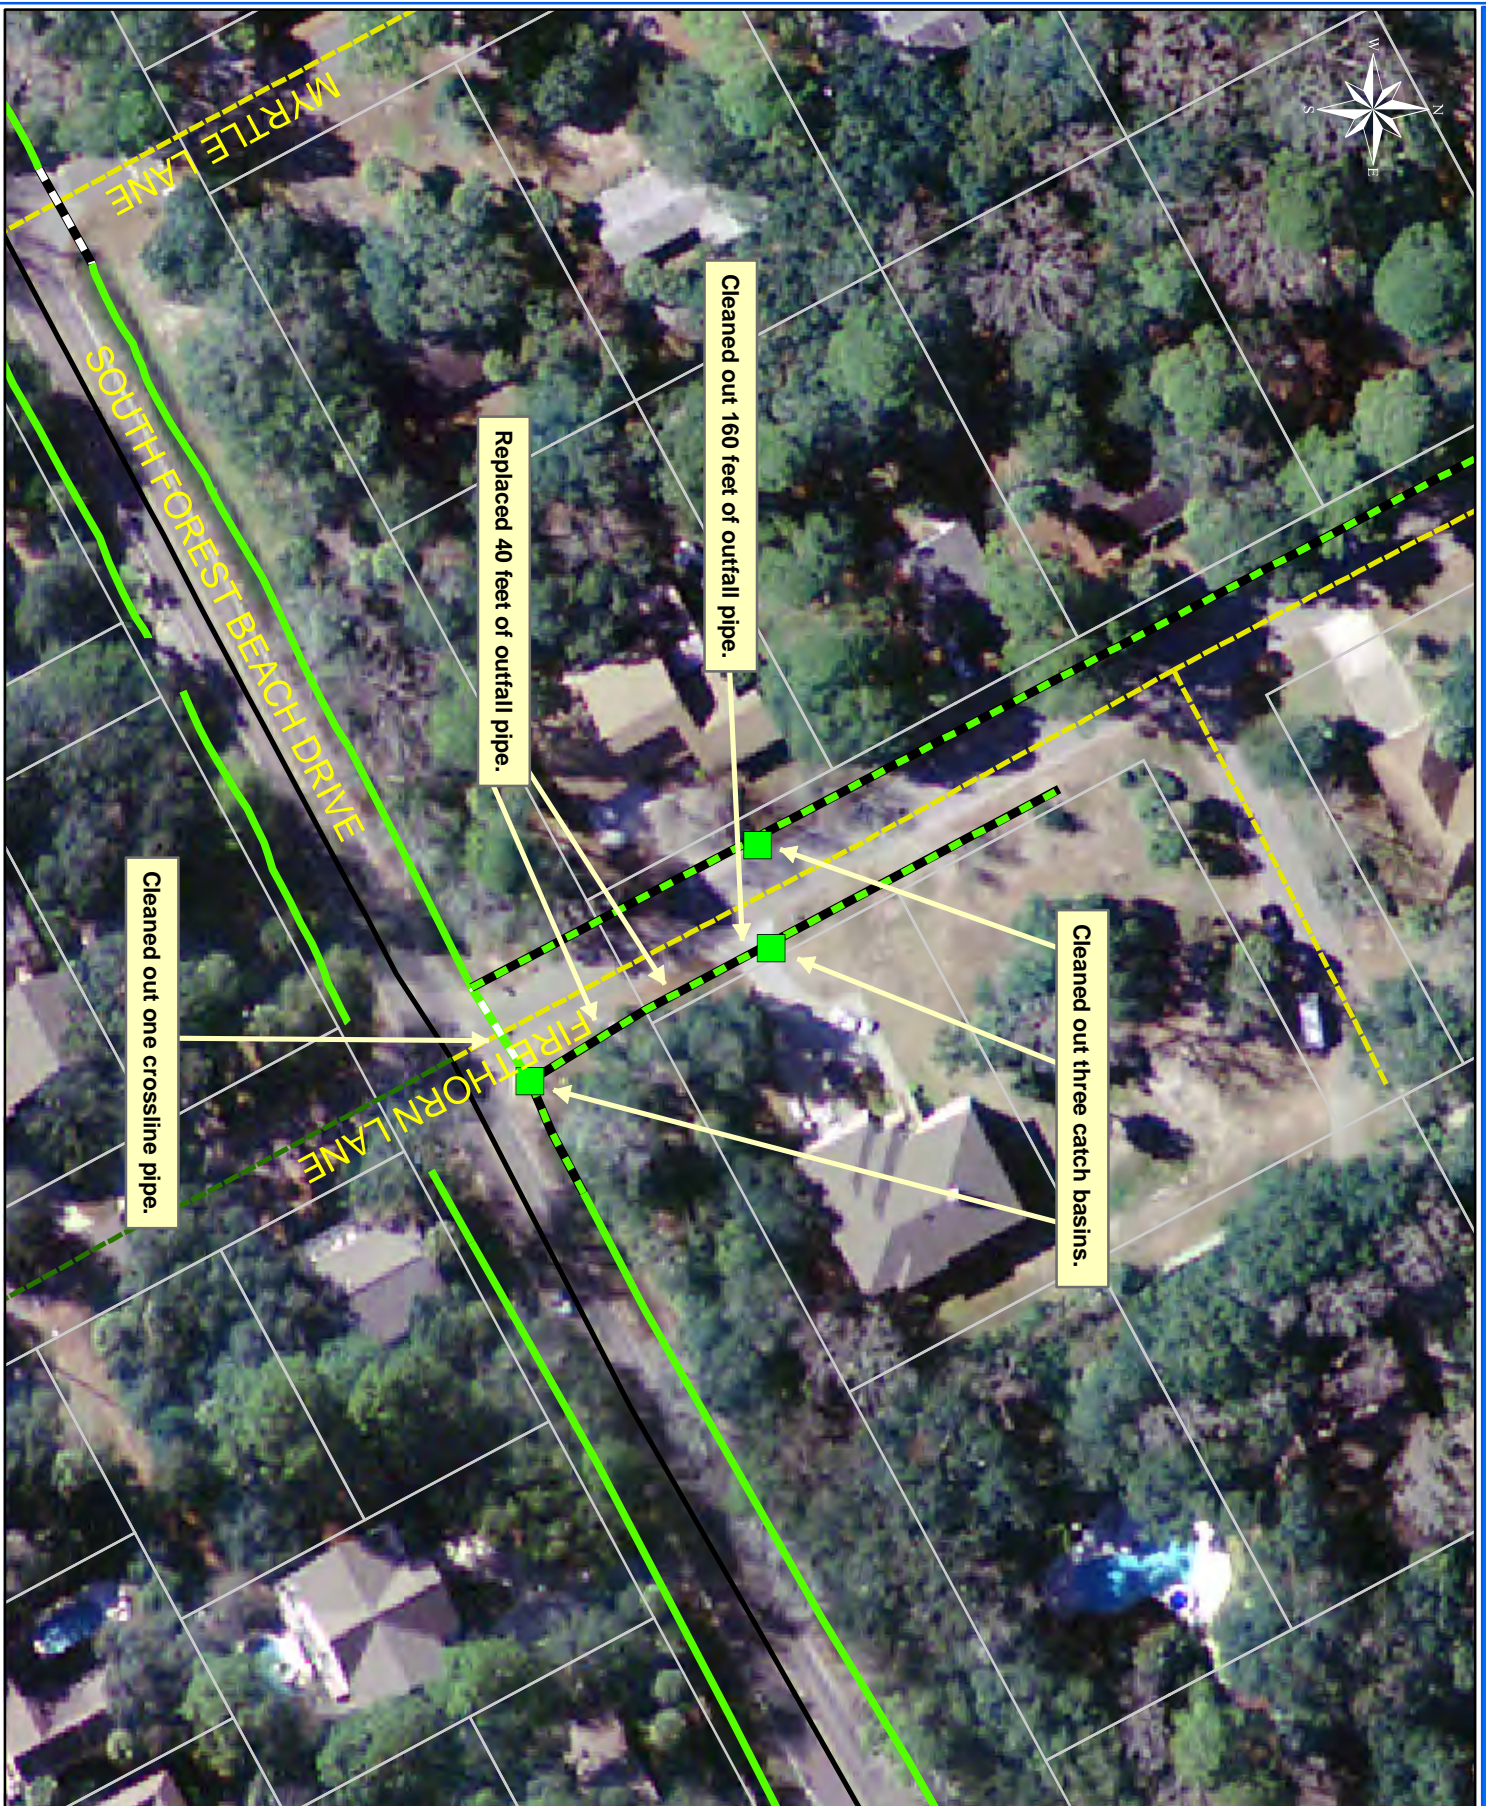
**Project:** Town of Hilton Head Island - Firehorn Lane

**Drainage/Water Quality Issue:** There was standing water on the road.

**Resolution:** This project replaced 40 feet of outfall pipe. The Utility also cleaned out 160 feet of outfall pipe, one crossline pipe, and three catch basins.

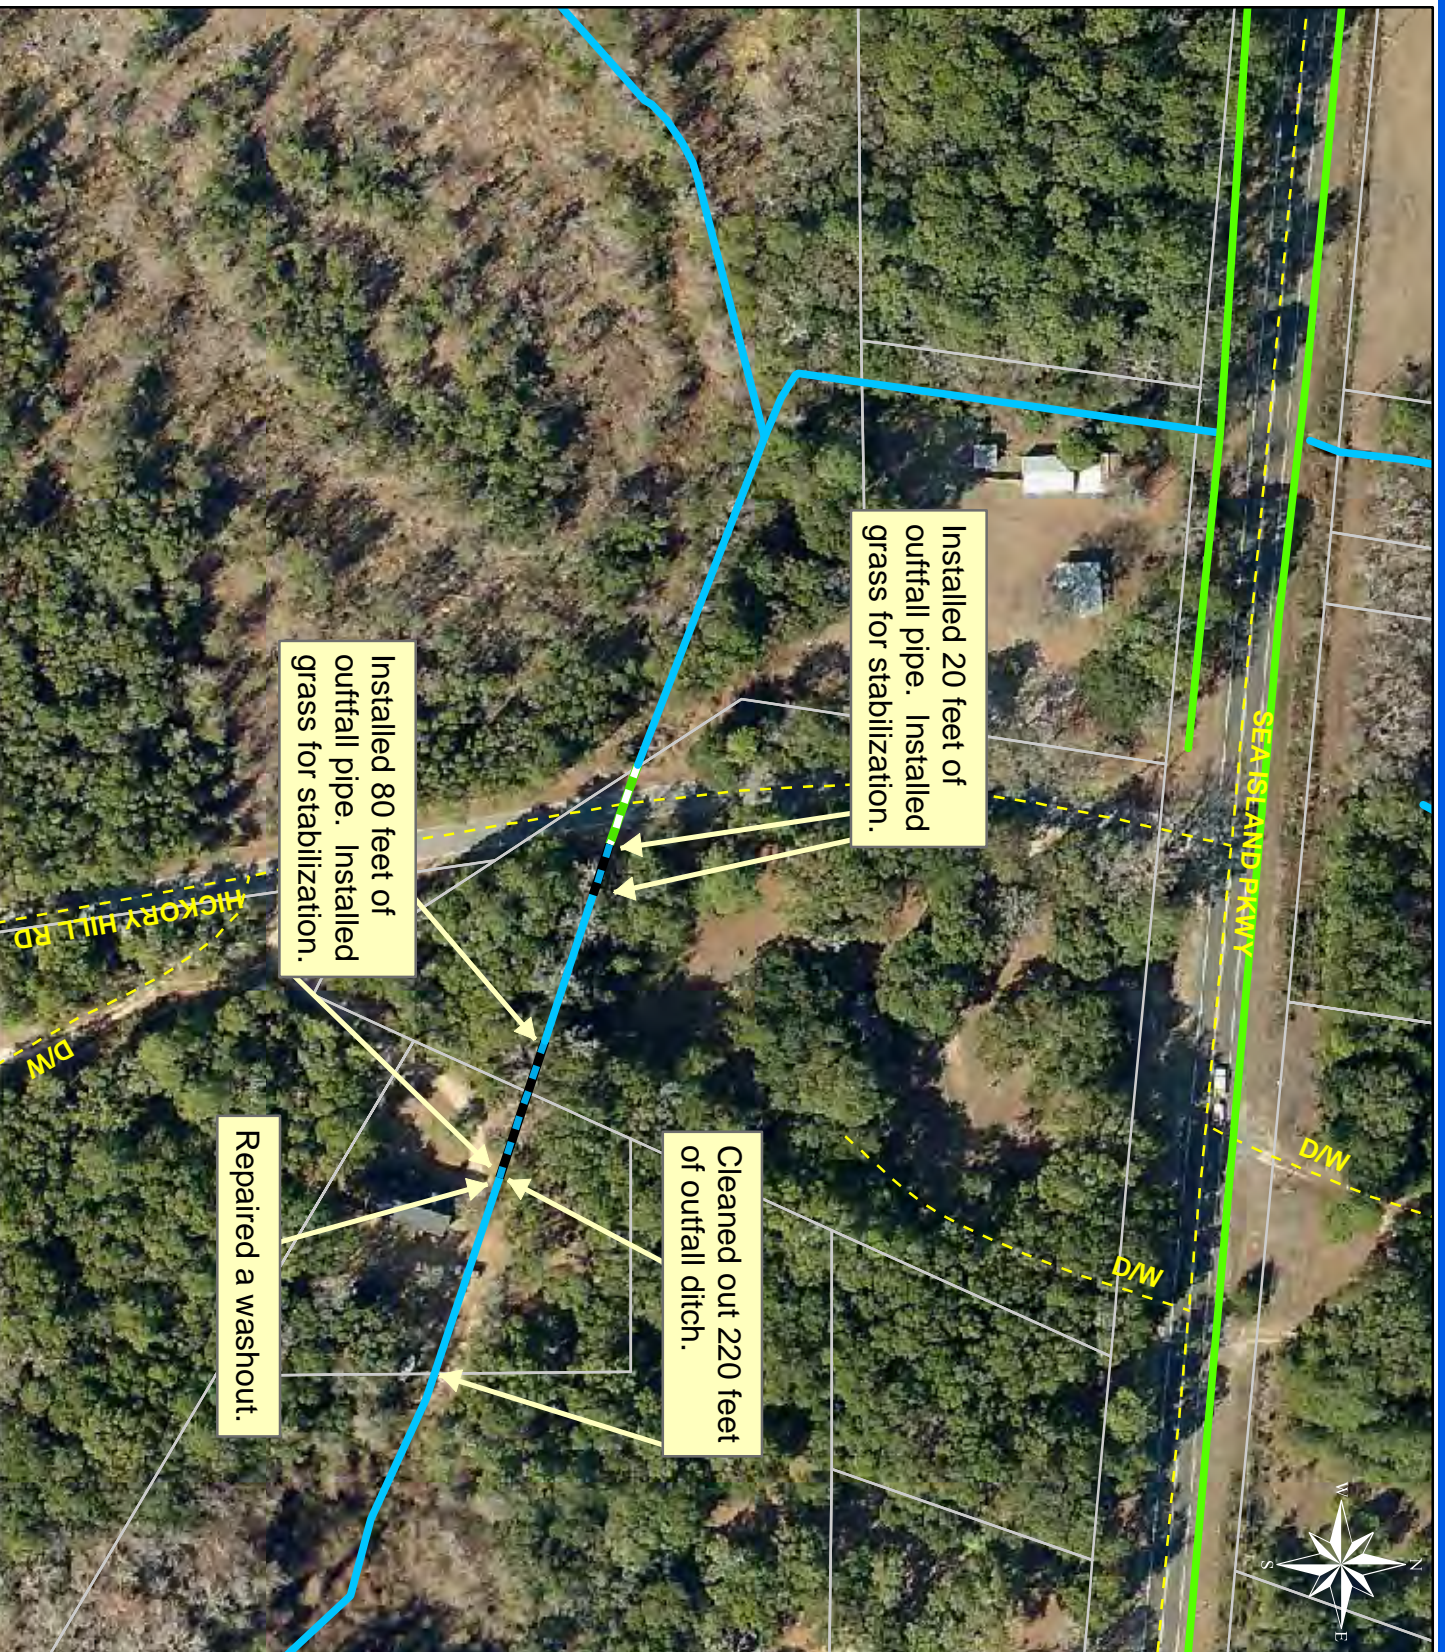
**Project:**  
Hickory Hill Road

**Drainage/Water Quality Issue:** After Hickory Hill Road was paved, the increase in rainwater runoff caused a washout at the discharge end of the outfall ditch. Also the access and easement for the drainage system were narrow, preventing the ditch near a property owner's home from being routinely cleaned out.

**Resolution:** This project cleared 220 feet of outfall ditch, repaired a wash out, and replenished stones. The Utility also installed 20 feet of outfall pipe upstream and 80 feet of outfall pipe downstream. Additionally, the Utility applied grass for stabilization.
