**Beaufort County**  
**Public Works**  
**Stormwater Infrastructure**  
*Project Summary*

**Project Summary:** Bonaire Circle South

**Activity:** Routine/Preventive Maintenance

Project #:  
2017-504

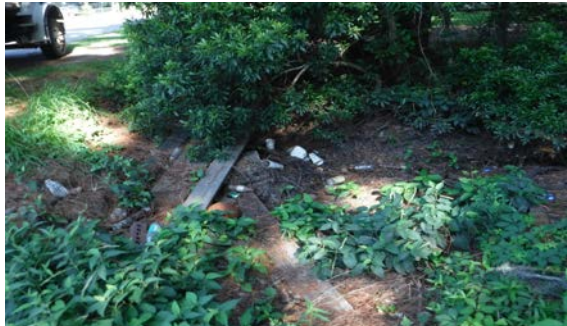
Before

Project improved 60 L.F. of drainage system. Removed blockage from flowline.  
Cleaned out 60 L.F. of roadside ditch.
