**Fiscal Year 2009**

## Stormwater Utility

### Project Report

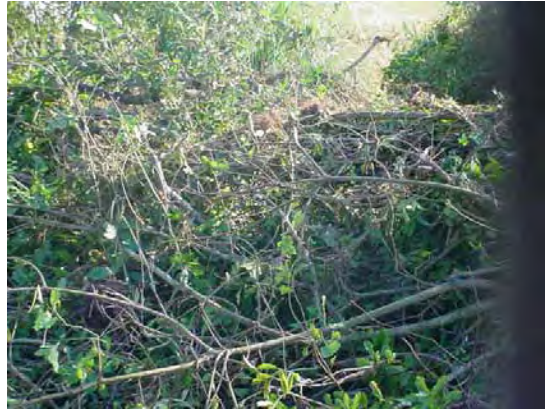
**Before**

**Drainage/Water Quality Issue:** The primary outfall ditch for this subdivision was wide, deep, and a safety hazard. Also, the access and easements for the drainage system within the subdivision were narrow and preventing the ditches from being routinely cleaned out.

**Resolution:** This project mowed 600 feet of outfall ditch, cleared 2,460 feet of outfall ditch and maintenance access, cleaned out 1,530 feet of roadside ditch, 1,080 feet of outfall ditch, and 90 feet of lateral ditches. The Utility also installed eleven catch basins, one crossline pipe, five access pipes, 2,610 feet of outfall pipe, 370 feet of lateral/outfall pipe, nine stone basins, upsized one driveway pipe, extended one driveway pipe, and cleaned out eleven driveway pipes. In addition, the Utility installed stones and applied grass for stabilization.

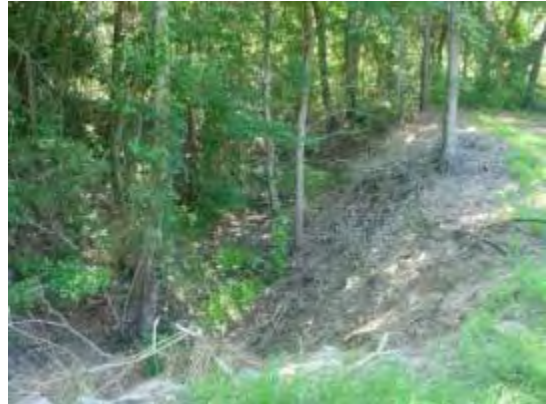
**Before**

**Drainage/Water Quality Issue:** After Hickory Hill Road was paved, the increase in rainwater runoff caused a washout at the discharge end of the outfall ditch. Also the access and easement for the drainage system were narrow, preventing the ditch near a property owner's home from being routinely cleaned out.

**Resolution:** This project cleared 220 feet of outfall ditch, repaired a wash out, and replenished stones. The Utility also installed 20 feet of outfall pipe upstream and 80 feet of outfall pipe downstream. Additionally, the Utility applied grass for stabilization.

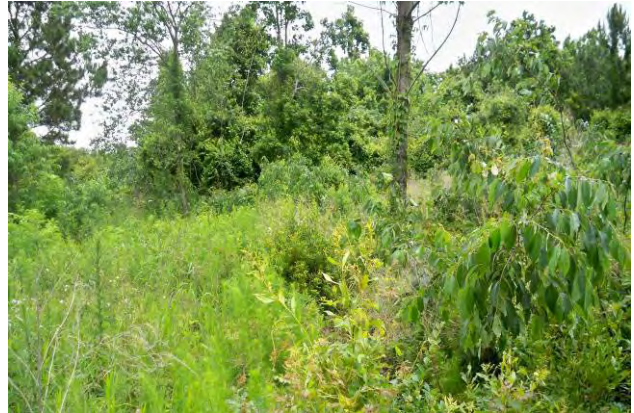
**Before**

**Drainage/Water Quality Issue:** The drainage infrastructure requires periodic mowing maintenance to function as designed. This controls woody growth (trees) and prevents blockages that could require a major cleaning effort due to system failure and damage to surrounding areas.

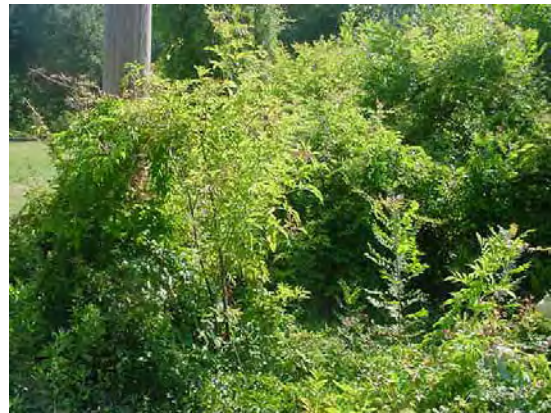
**Before**

**Drainage/Water Quality Issue:** The drainage infrastructure requires periodic mowing maintenance to function as designed. This controls woody growth (trees) and prevents blockages that could require a major cleaning effort due to system failure and damage to surrounding areas.

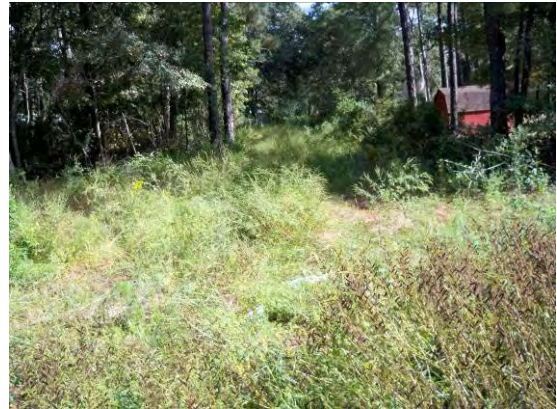
**Before**

**Drainage/Water Quality Issue:** The drainage infrastructure requires periodic mowing maintenance to function as designed. This controls woody growth (trees) and prevents blockages that could require a major cleaning effort due to system failure and damage to surrounding areas.

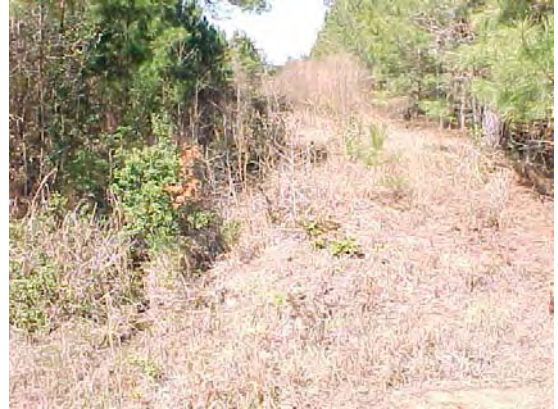
**Before**

**Drainage/Water Quality Issue:** The drainage infrastructure requires periodic mowing maintenance to function as designed. This controls woody growth (trees) and prevents blockages that could require a major cleaning effort due to system failure and damage to surrounding areas.

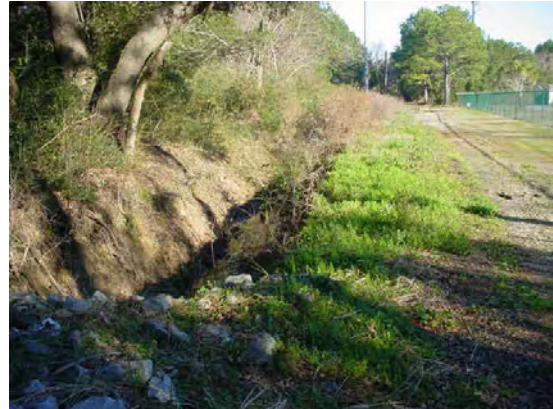
**Before**

**Drainage/Water Quality Issue:** The drainage infrastructure requires periodic mowing maintenance to function as designed. This controls woody growth (trees) and prevents blockages that could require a major cleaning effort due to system failure and damage to surrounding areas.

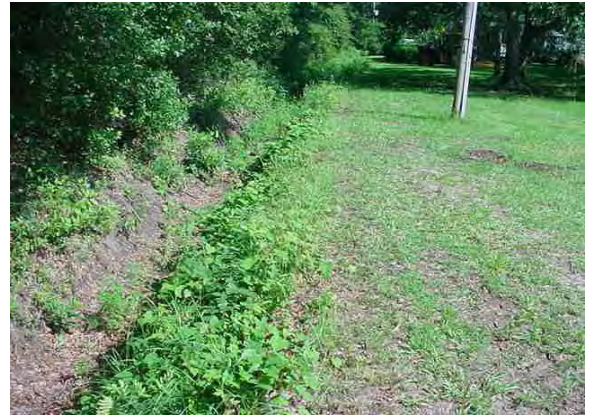
**Before**

**Drainage/Water Quality Issue:** The drainage infrastructure requires periodic mowing maintenance to function as designed. This controls woody growth (trees) and prevents blockages that could require a major cleaning effort due to system failure and damage to surrounding areas.
