Beaufort County Public Works Stormwater Infrastructure Project Summary

Project Summary: Lost Island Road

Activity: Routine/Preventive Maintenance

Duration: 12/2/15 - 2/11/16

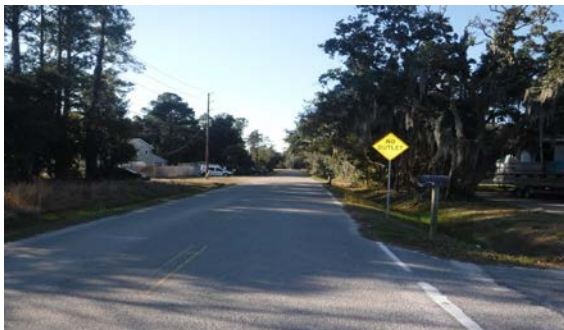
Before

Project improved 3,994 L.F. of drainage system. Cleaned out 3,720 L.F. of valley drain and 820 L.F. of roadside ditch.
Jetted (1) crossline pipe, (11) driveway pipes and 274 L.F. of roadside pipe. Installed rip rap for erosion control.
